**UNITED STATES ENVIRONMENTAL PROTECTION AGENCY  
REGION 5  
77 WEST JACKSON BOULEVARD  
CHICAGO, ILLINOIS 60604**

**SUBJECT:** CLEAN AIR ACT INSPECTION REPORT  
S.H. Bell Company, Chicago, Illinois

**Facility Name:** S.H. Bell Company

**Date of Inspection:** August 16, 2017

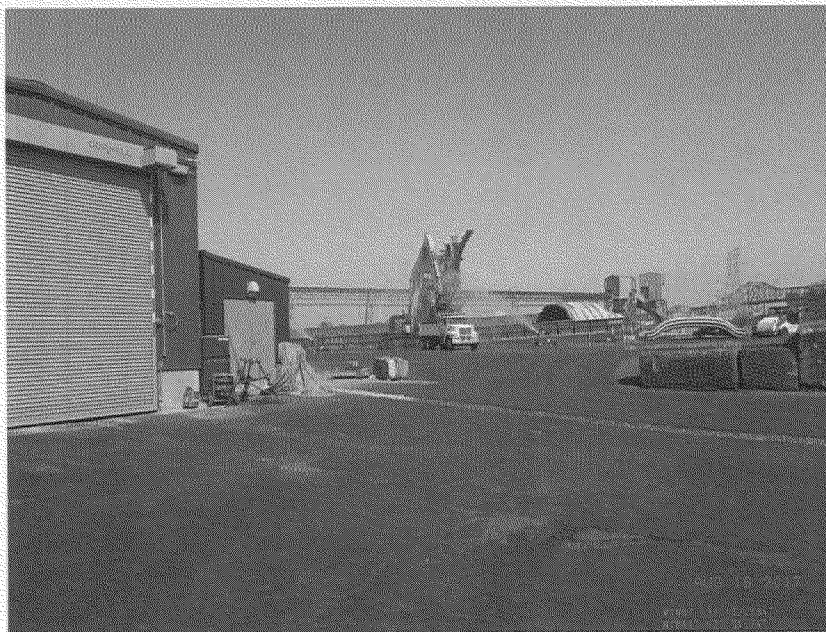
**RIMG0006**

During the tour SHB was unloading a barge of silicone manganese. Two mobile misters were operation. One was creating a “curtain” downwind of the operations and the second was directly angled onto the scooping and truck loading operations next to the barge. This material is considered one that cannot get wet, though SHB does not consider the mobile misters as “wetting” the material, since the misters only generate a small gallon per minute flow.

<b>1. Inspector Name: Molly Smith</b>		<b>2. Archival Record Location: C:Drive</b>		
<b>Image Number</b>	<b>File Name</b>	<b>Date and Time (incl. Time zone and DST)</b>	<b>Latitude and Longitude</b>	<b>Description of Image</b>
RIMG0001	RIMG0001	August 16, 2017 at 9:54 AM	NA	Portable baghouse on Ryerson Building
RIMG0002	RIMG0002	August 16, 2017 at 10:01 AM	NA	Loading of pig iron onto truck for shipment
RIMG0003	RIMG0003	August 16, 2017 at 10:02 AM	NA	Street sweeper on-site
RIMG0004	RIMG0004	August 16, 2017 at 10:06 AM	NA	Rail unloading enclosure
RIMG0005	RIMG0005	August 16, 2017 at 10:11 AM	NA	Norcon Building with baghouse
RIMG0006	RIMG0006	August 16, 2017 at 10:13 AM	NA	Barge unloading with mobile mister (silicone manganese)
RIMG0007	RIMG0007	August 16, 2017 at 10:19 AM	NA	Norcon Building with baghouse

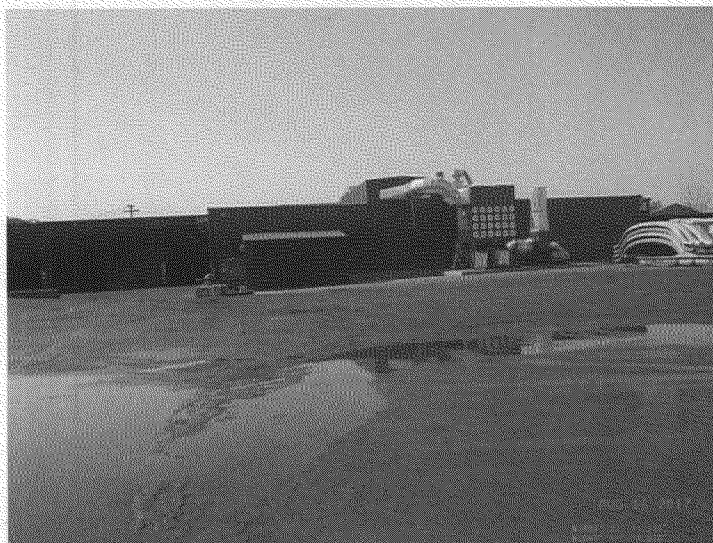
**RIMG0007**

1. SHB has purchased two more portable/mobile misting units, for a total of four on site now.
2. The Norcon building baghouse is up and running, as of August 16, 2018. There will be a shakedown period; however, the unit is fully operational.
